Trees and Sewer Lines

Defective Sewer Lines

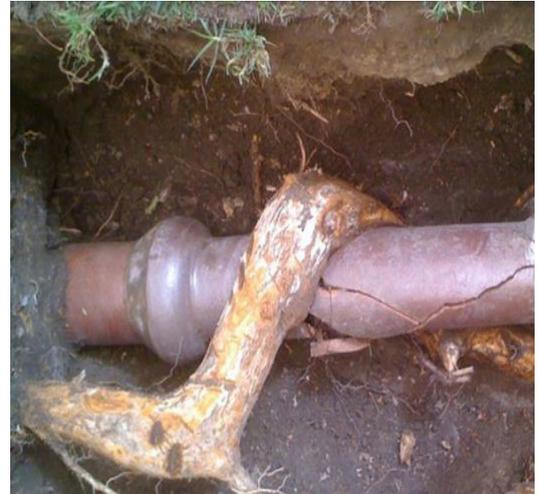
The most effective solution to the problem of roots in sewers is the replacement or repair of the damaged pipe. Unfortunately, open excavation can lead to extensive root disturbance and nearby tree loss. New methods of minimal site disturbance for pipe replacement are the burst pipe method, relining the pipe, the injection of polyurethane grouting, and slip lining. As work is performed on the pipes, quality, watertight construction is of premier importance. In certain areas, wrapping pipelines in a barrier fabric may be the best solution.
